VAKHTANG BERIDZE  
1ST INTERNATIONAL SYMPOSIUM  
OF GEORGIAN CULTURE

# Georgian Art

in the Context of European  
and Asian Cultures

## **BIODETERIORATION OF MURAL PAINTINGS IN THE CHURCH OF THE VIRGIN IN MARTVILI (GEORGIA)**

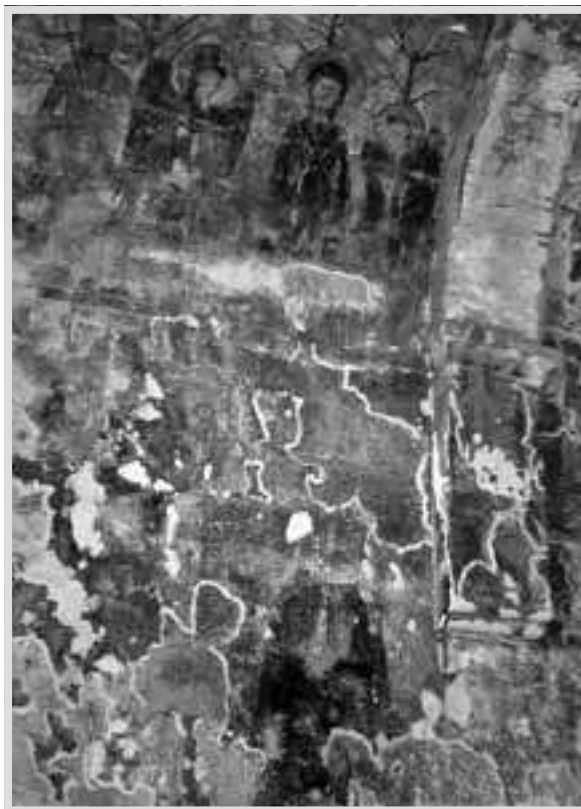
In the case of the Martvili church, the biodeterioration problem looked particularly heavy on the mural paintings in the western porch, where diffuse growths of blackish, green and pink patinas of biological origin were easily detectable (Fig. 2). According with the literature, the degradation of frescoes was greater in ar-

eas adjoining windows and doors, and in proximity to the ground. In these areas microorganisms are found in greater quantities, evidence of the importance of air-flow either because of the easier deposition of spores linked to air movement, or the greater degree of humidity linked to a fall in temperature (Nugari et al. 2005).

2 Different biodeterioration pattern in the western porch (left with respect to the entrance).

Considering this, we suggested the use of Preventol R80 at 2%, diluted in distilled water for all the alteration forms (taking into consideration that the presence of salts in the normal water can reduce the biocidal activity), as the best compromise in terms of efficiency/safety. The results indicated the need to repeat the treatments (two or sometimes three times), staggered with one week, and finally cleaning with distilled water. In the case of dense patinas, especially the black ones, a partial mechanical removal was also suggested, eventually using a compress for favouring the contact.

As it was made in other critical situations (hypo-geans, crypts e.g.), a new system of isolation of the entrance door, reducing the direct income of humidity especially in cold winters, without stopping completely ventilation, seems to be necessary.
